EXPANDED FUNGAL REPORT TM

Report Date: 00/00/0000
Project: <Street Address>
EMSL Order: 000000000

Spore Trap ASSESSMENT Report™ Air-O-Cell™ Analysis of Fungal Spores & Particulates (Methods MICRO-SOP-201, ASTM D7391)

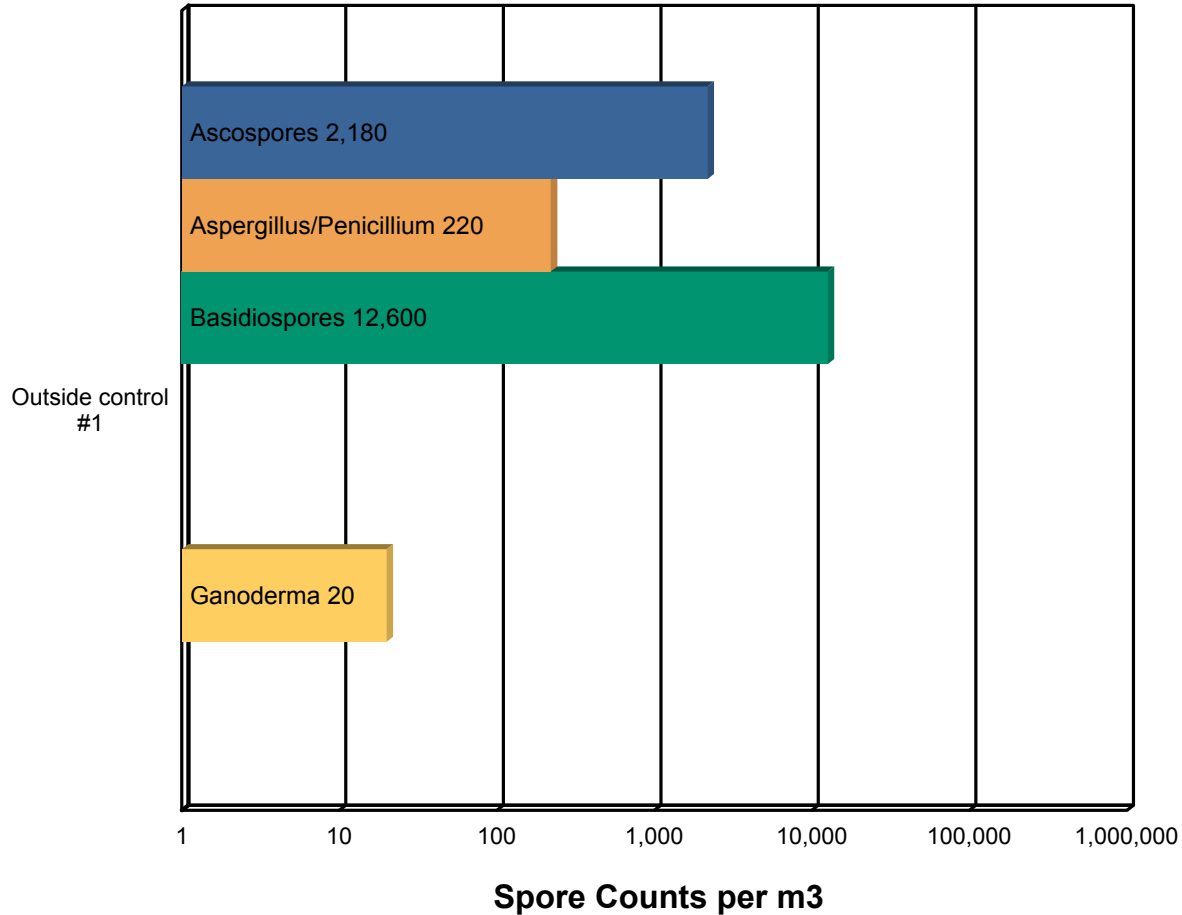
Spore Trap Report: Total Counts

Ascospores	Aspergillus/Penicillium	Basidiospores	Cladosporium
Epicoccum	Ganoderma	Myxomycetes++

* The chart is displayed using a logarithmic scale. Bar size is not directly proportional to the number of spores.

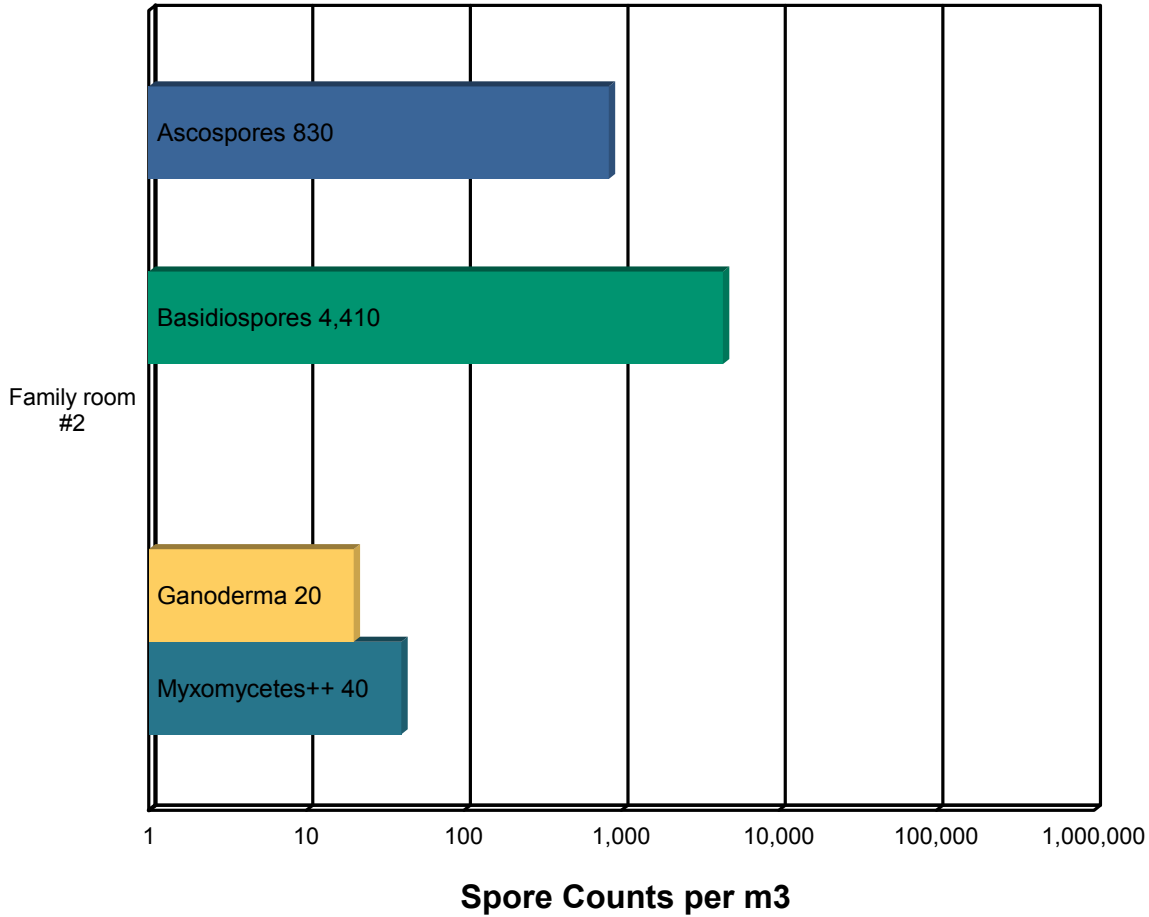
Spore Trap Report: Total Counts

Ascospores	Aspergillus/Penicillium	Basidiospores	Cladosporium
Epicoccum	Ganoderma	Myxomycetes++

* The chart is displayed using a logarithmic scale. Bar size is not directly proportional to the number of spores.

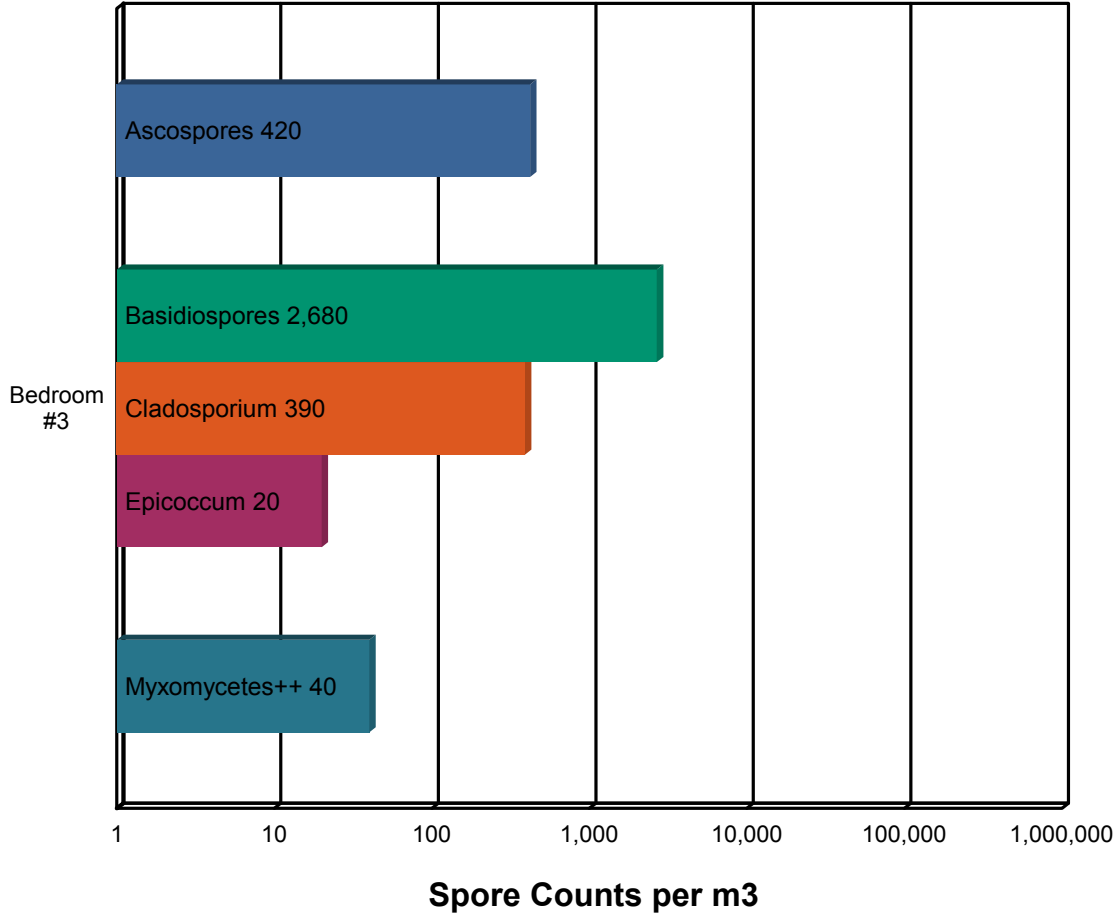
Spore Trap Report: Total Counts

Ascospores	Aspergillus/Penicillium	Basidiospores	Cladosporium
Epicoccum	Ganoderma	Myxomycetes++

* The chart is displayed using a logarithmic scale. Bar size is not directly proportional to the number of spores.

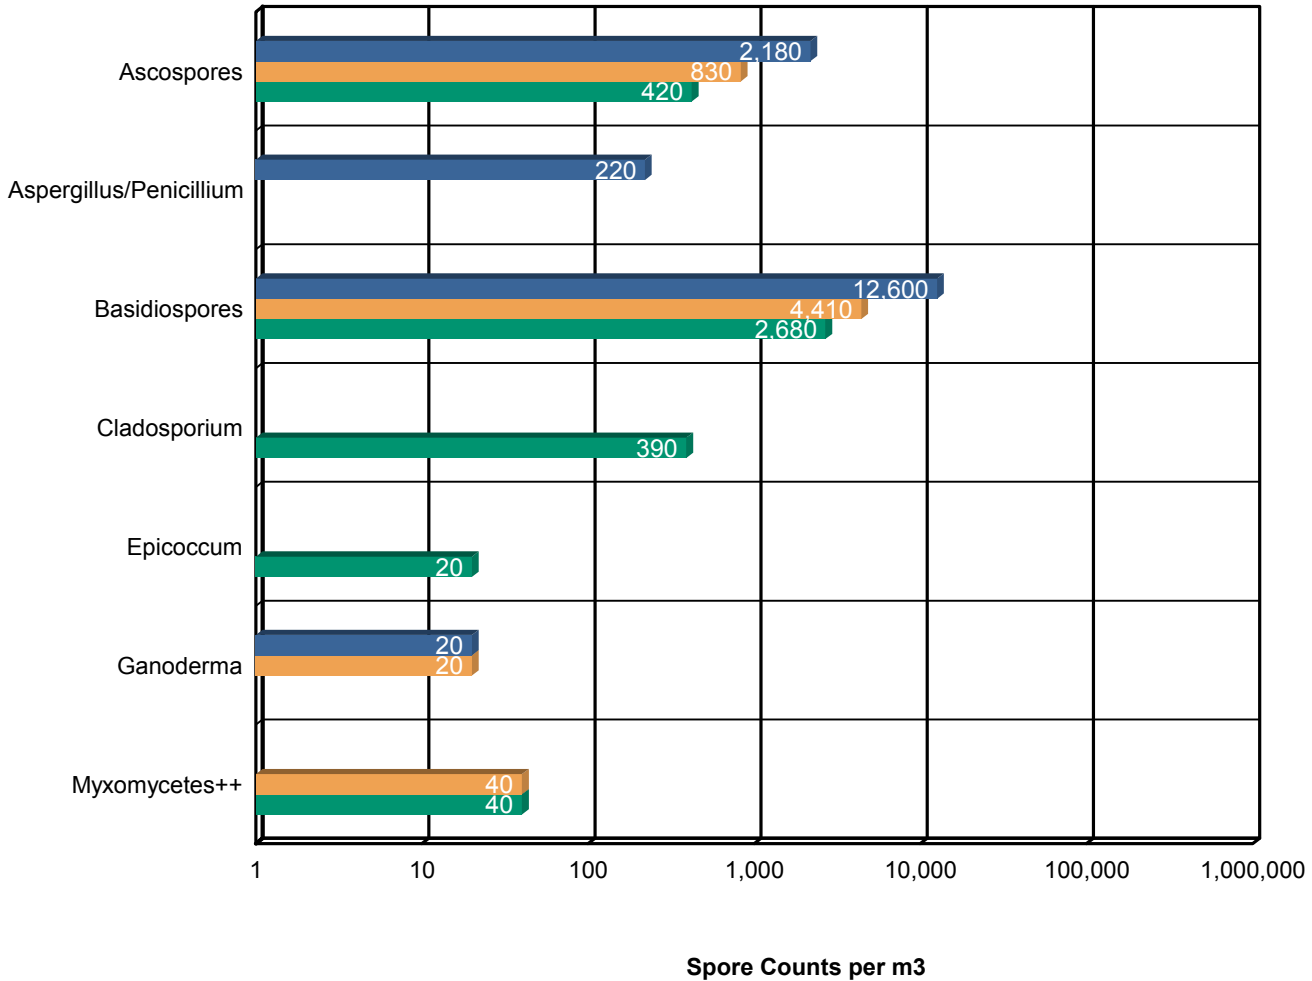
Background Comparison Chart

* The chart is displayed using a logarithmic scale. The bar size is not directly proportional to the number of spores.
